Quality Assurance Stand at KSU

Status Update and Test Results

Sergey Korjenevski
Kansas State University
January 23, 2003

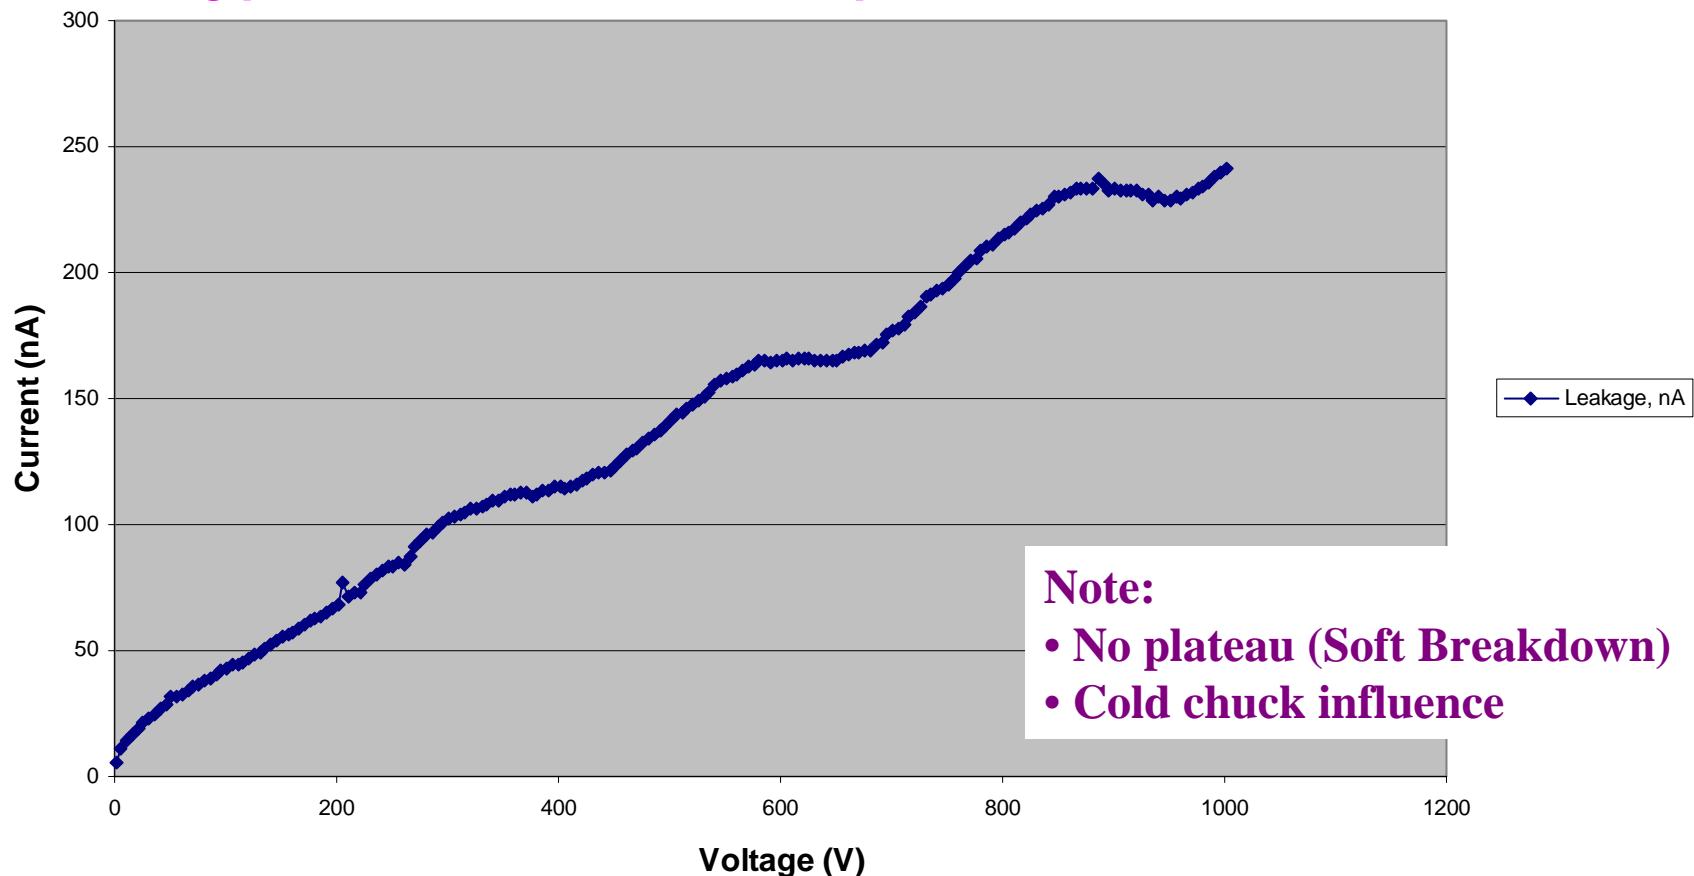
- Leakage Current
 - ◆ Typical behavior example

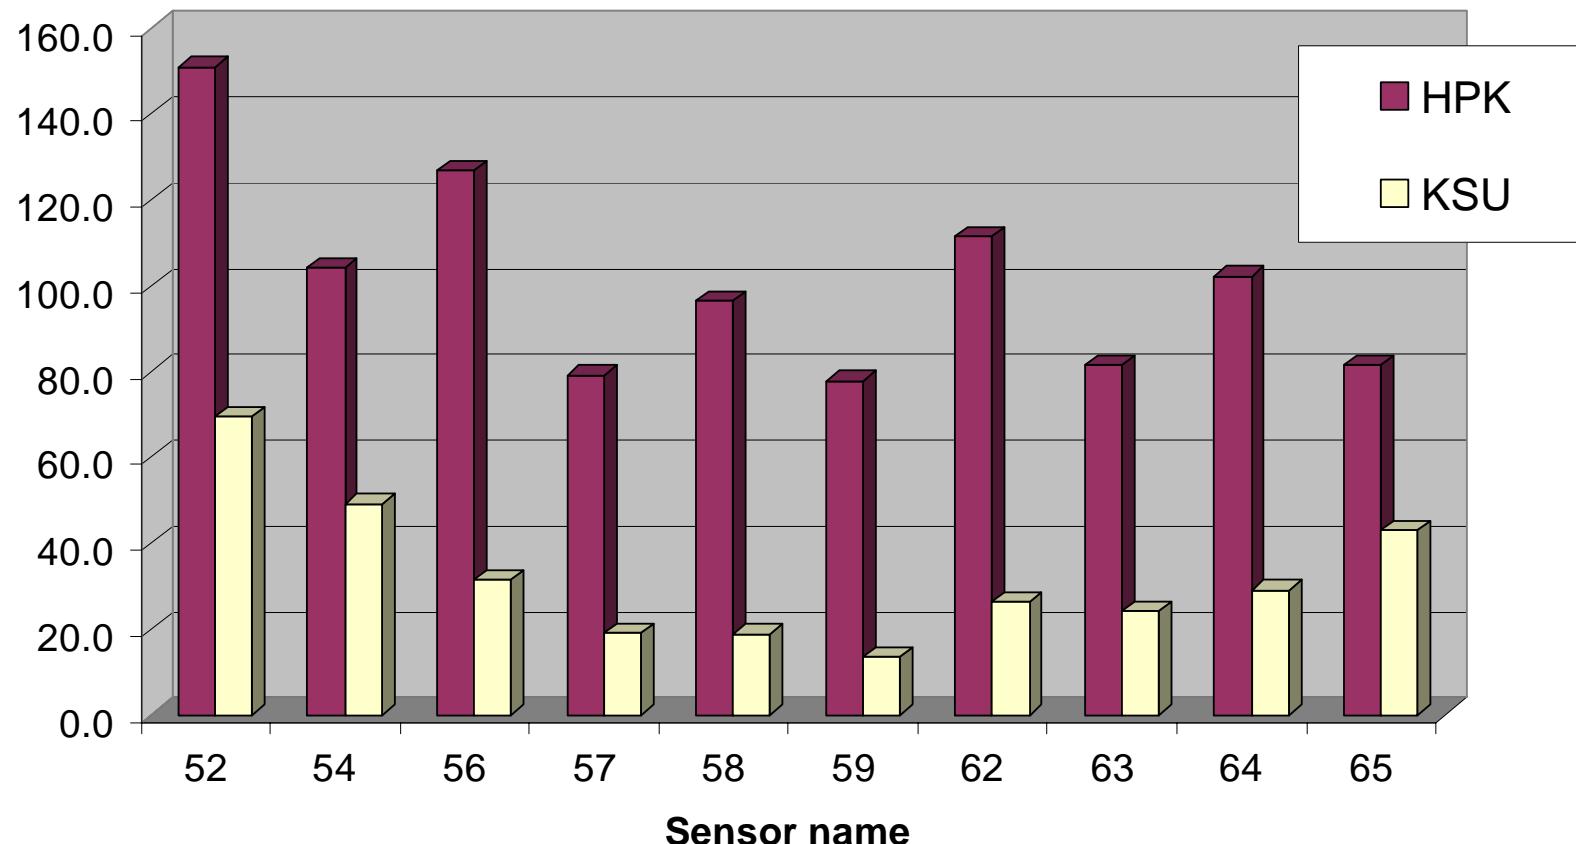
Leakage at 100V bias

- Leakage Current comparison

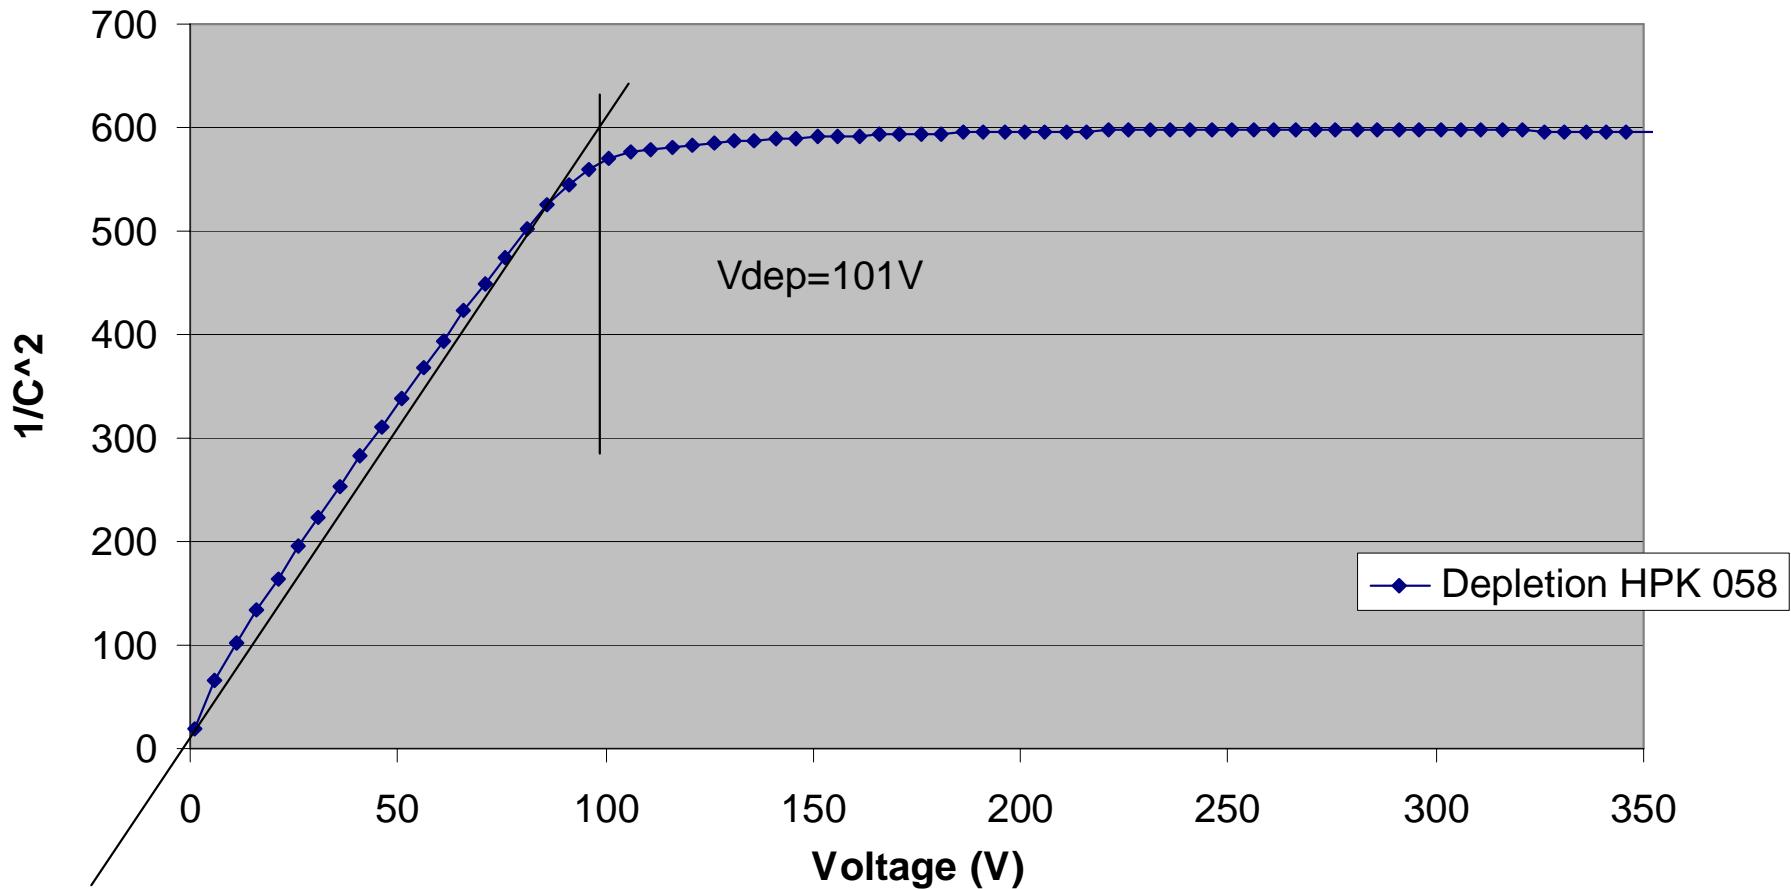
- Depletion Voltage Typical Example

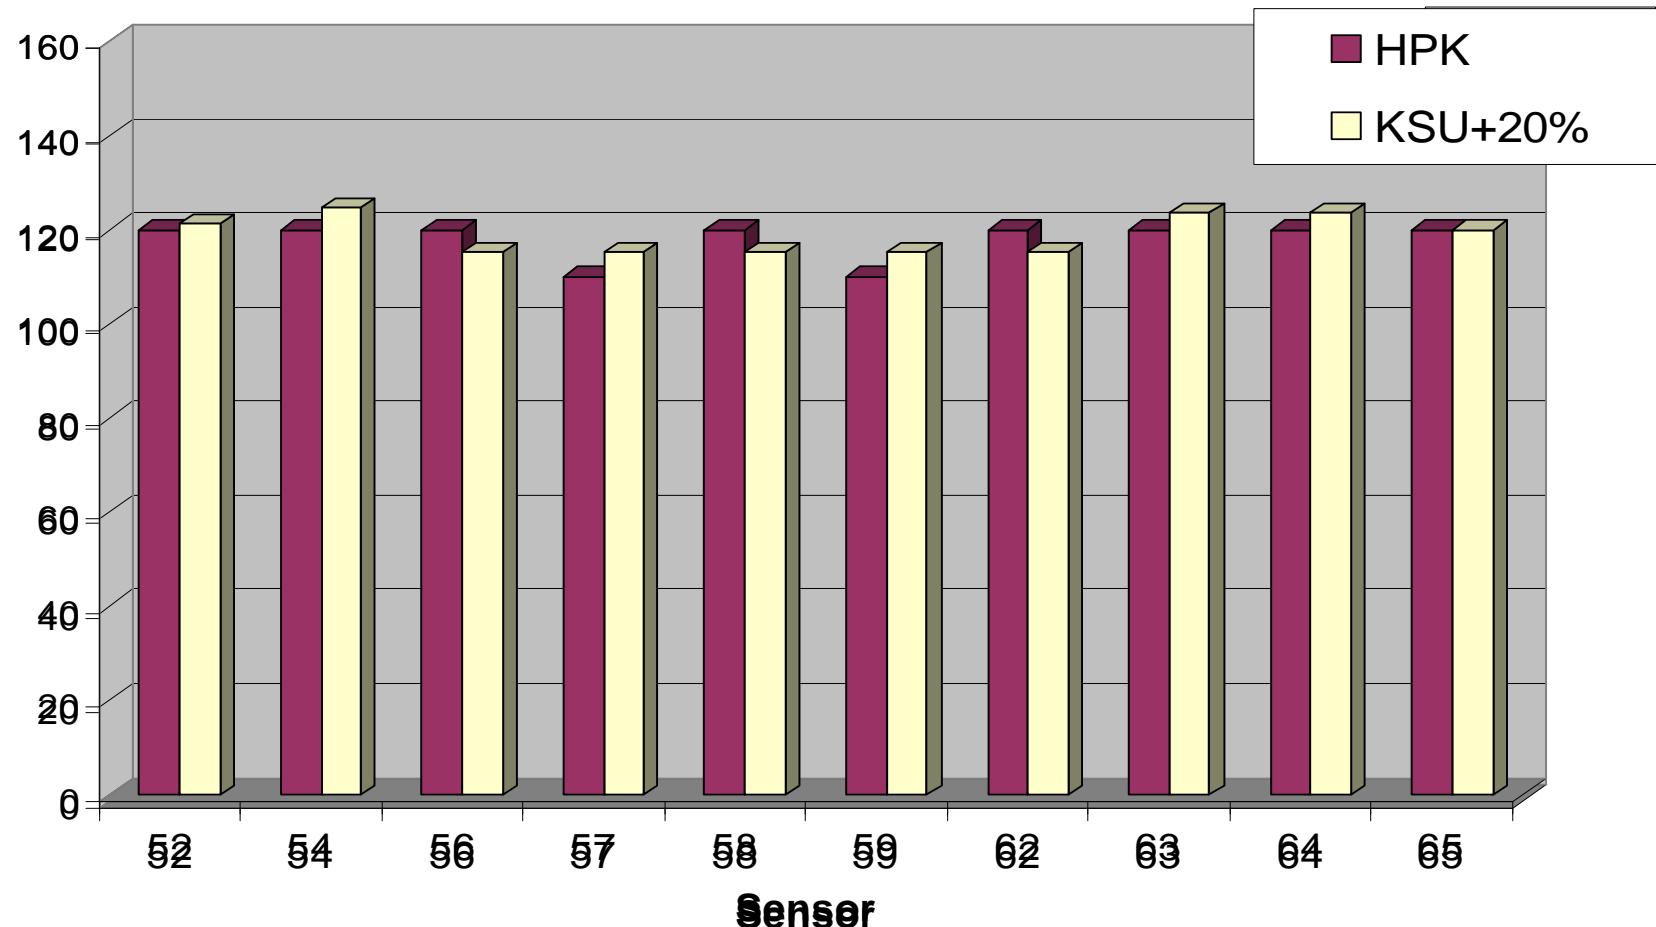
- Depletion Voltage Comparison

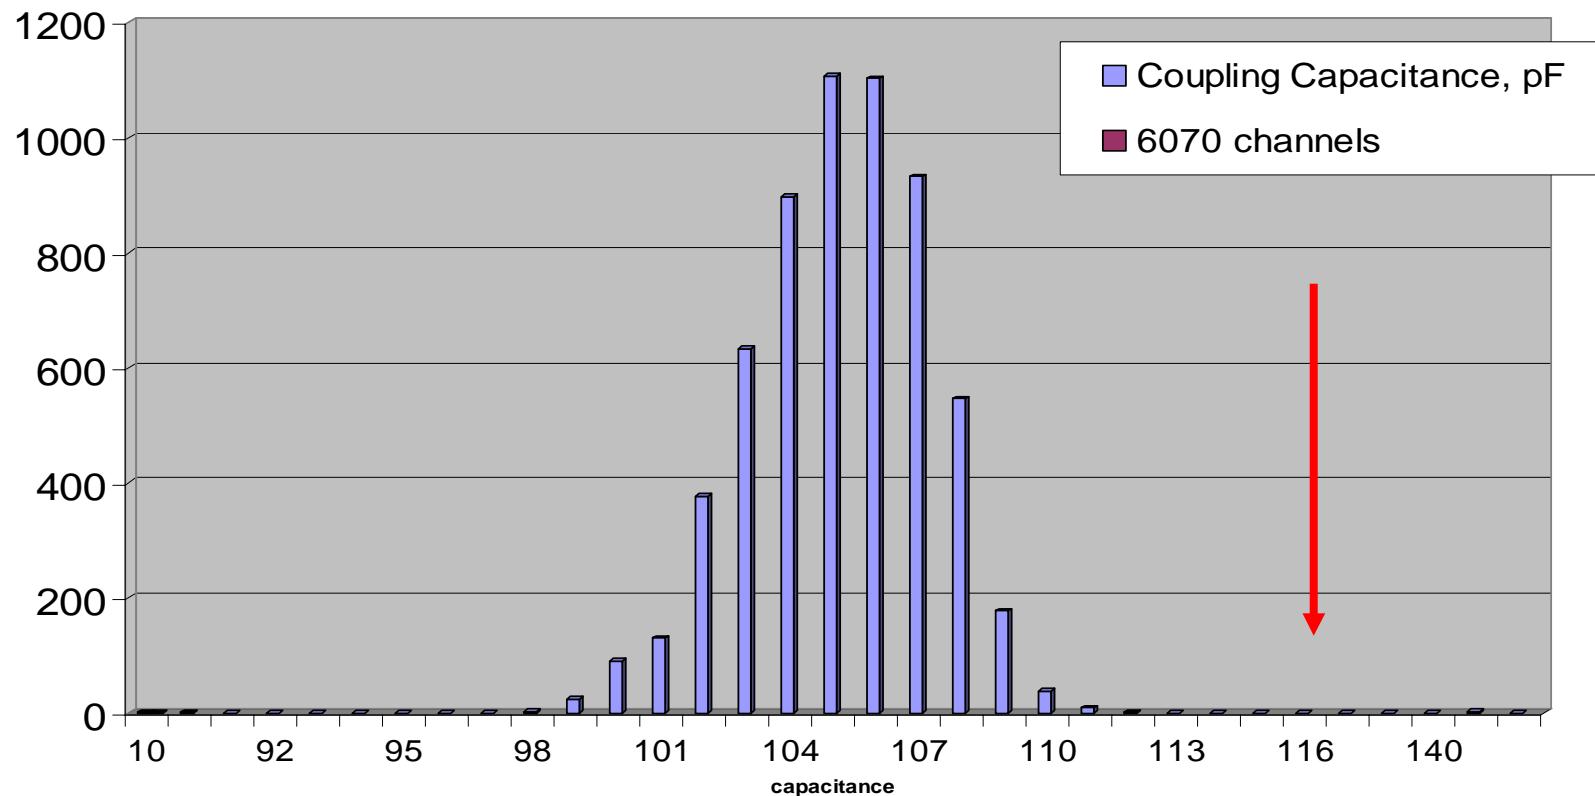
- ◆ HPK claims 2 bad channels on 065
- ◆ KSU result 6 bad channels overall
- ◆ Coupling Capacitance setup was changed implementing DC neighboring strip to detect shorts

- Strip Measurements
 - ◆ Coupling capacitance @ 1kHz

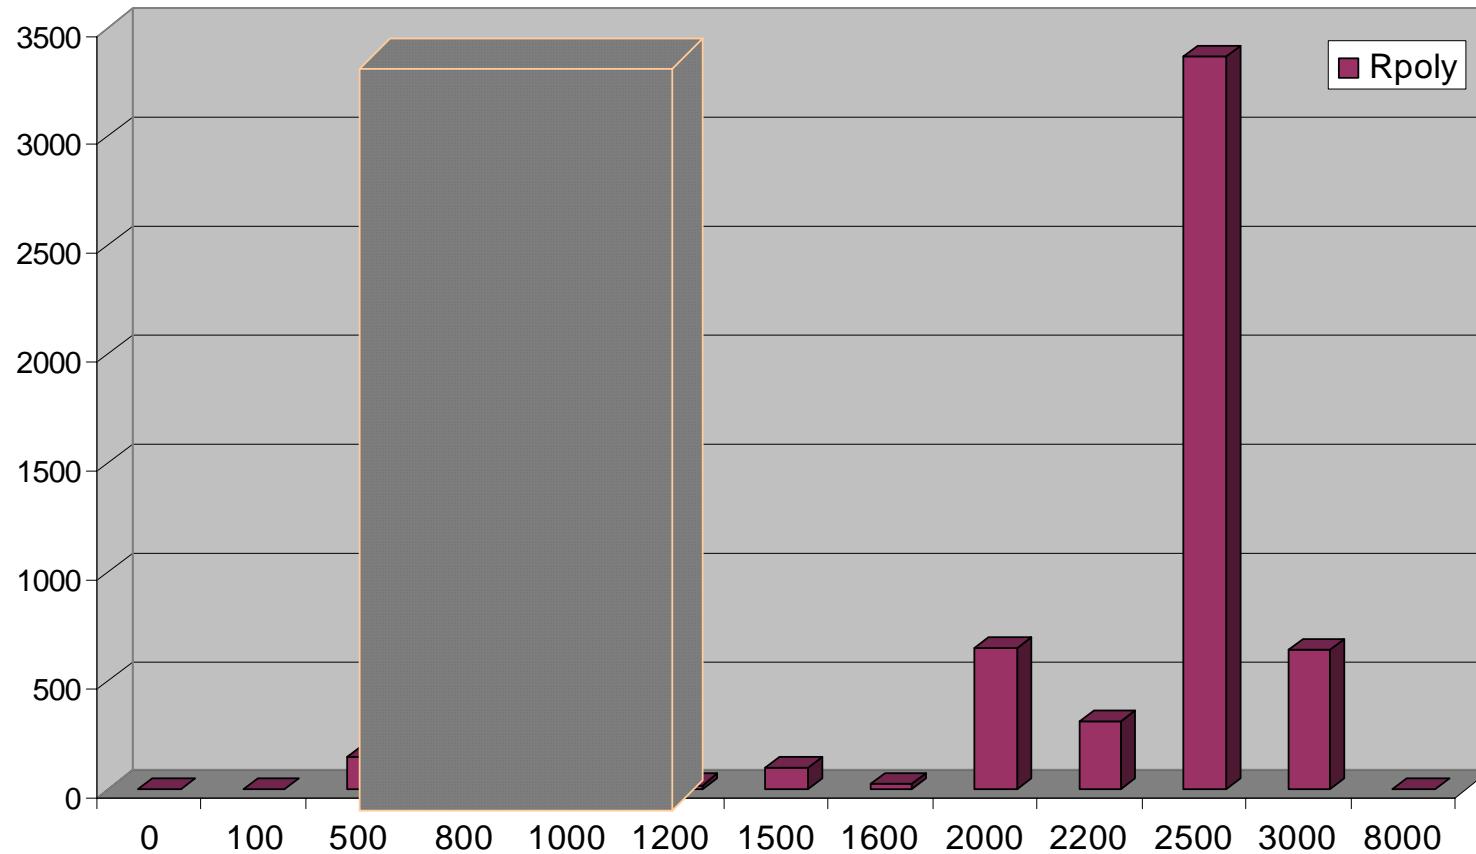
- Strip Measurements
 - ◆ R poly

- L2 sensors
 - ◆ Visual inspection was skipped up to now
 - ◆ All characteristics within specifications except poly silicon resistor
- New software package
 - ◆ Input file will define all testing parameters
 - ◆ Data base and output format - did do yet

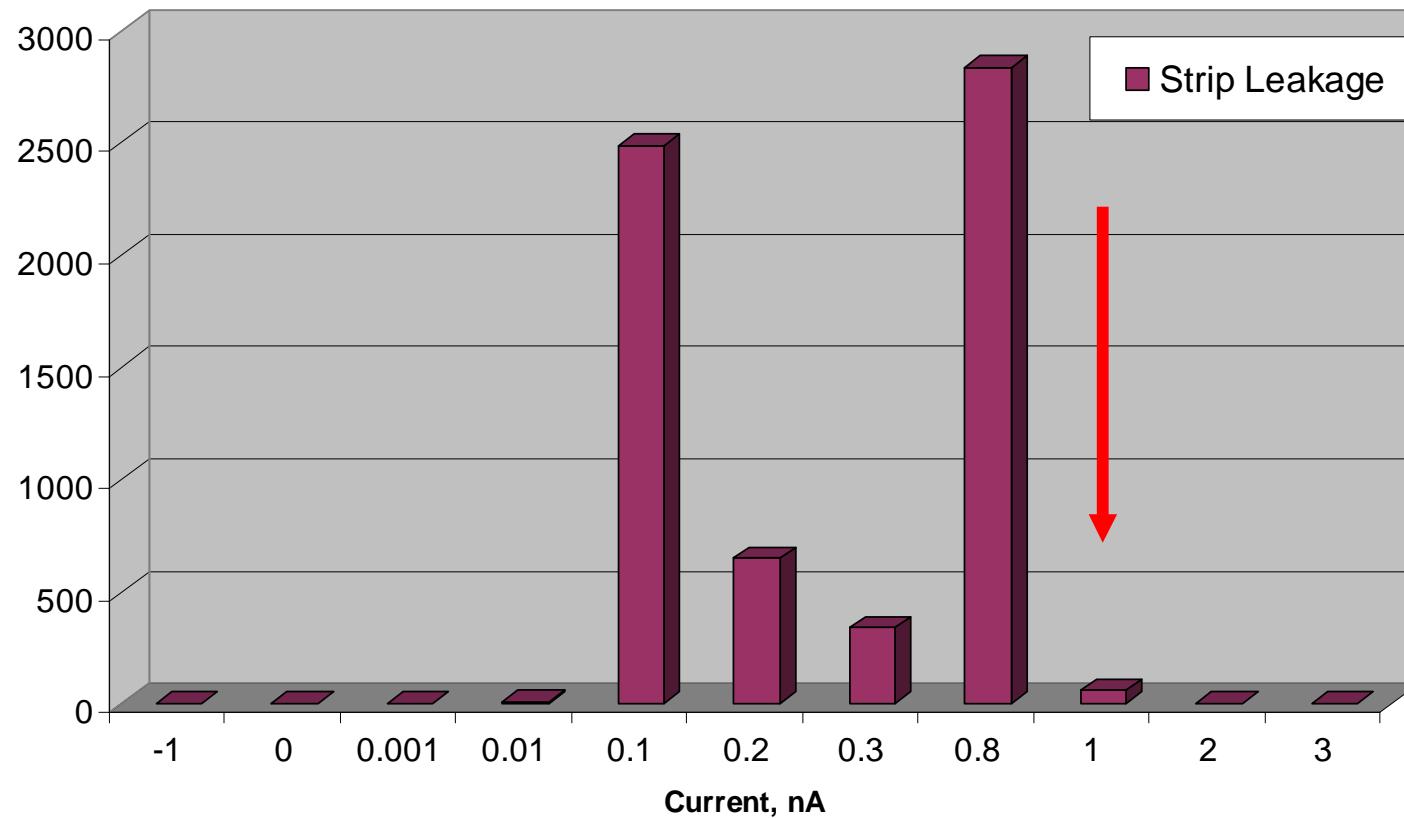
- Strip Measurements
 - ◆ Strip leakage current
